THIELSCH ENGINEERING, INC.

**METALLURGICAL EXAMINATION OF
STRESS CORROSION CRACKING
IN BOTTOM ASH SEAL CURTAIN SECTION
UNIT NO. 2
INTERMOUNTAIN GENERATING STATION
INTERMOUNTAIN POWER COMPANY
DELTA, UTAH**

March 3, 1993

Report No. 5455

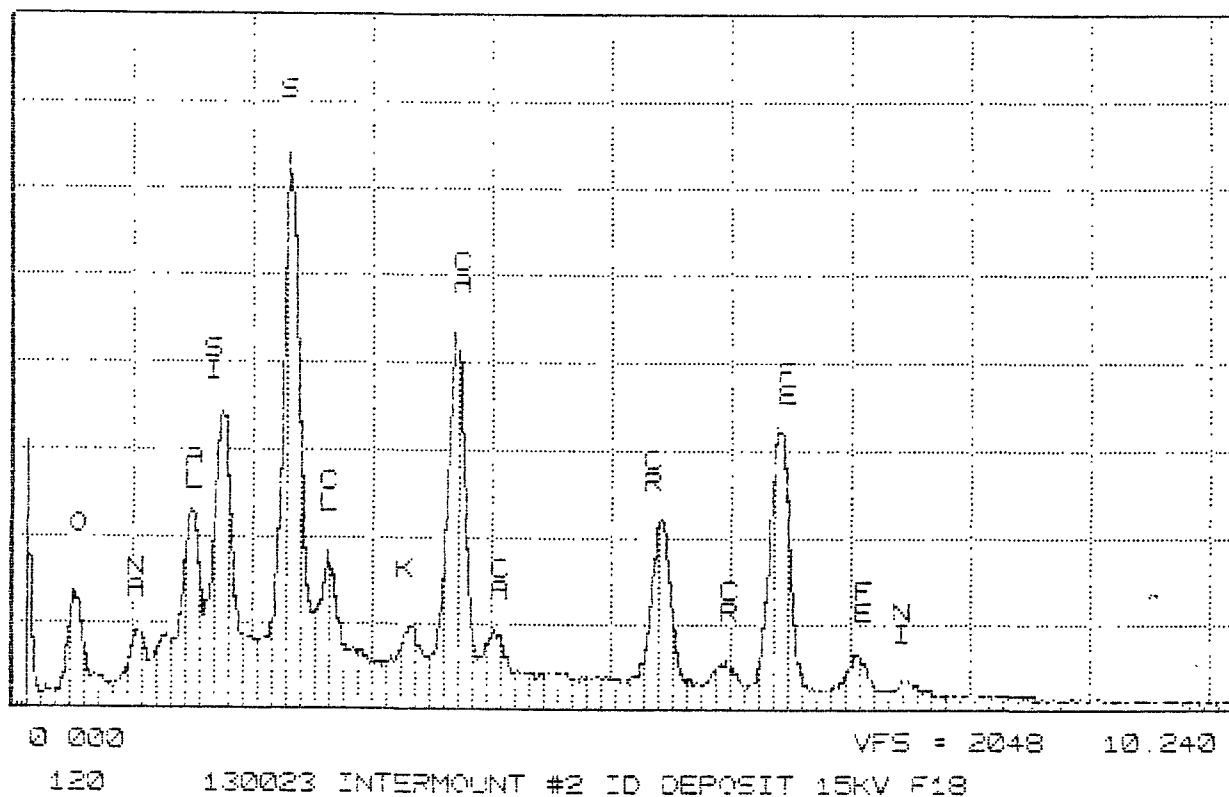
Location C is also identified in Fig. 6. Heavy surface scale was observed. The Energy Dispersive Spectral (EDS) plot is provided in Fig. 16. High levels of sulfur, chlorine, silicon, oxygen, calcium and potassium were detected. Iron, chromium and nickel represent the base metal.

Fig. 16. Energy Dispersive Spectral (EDS) plot recorded of location C.

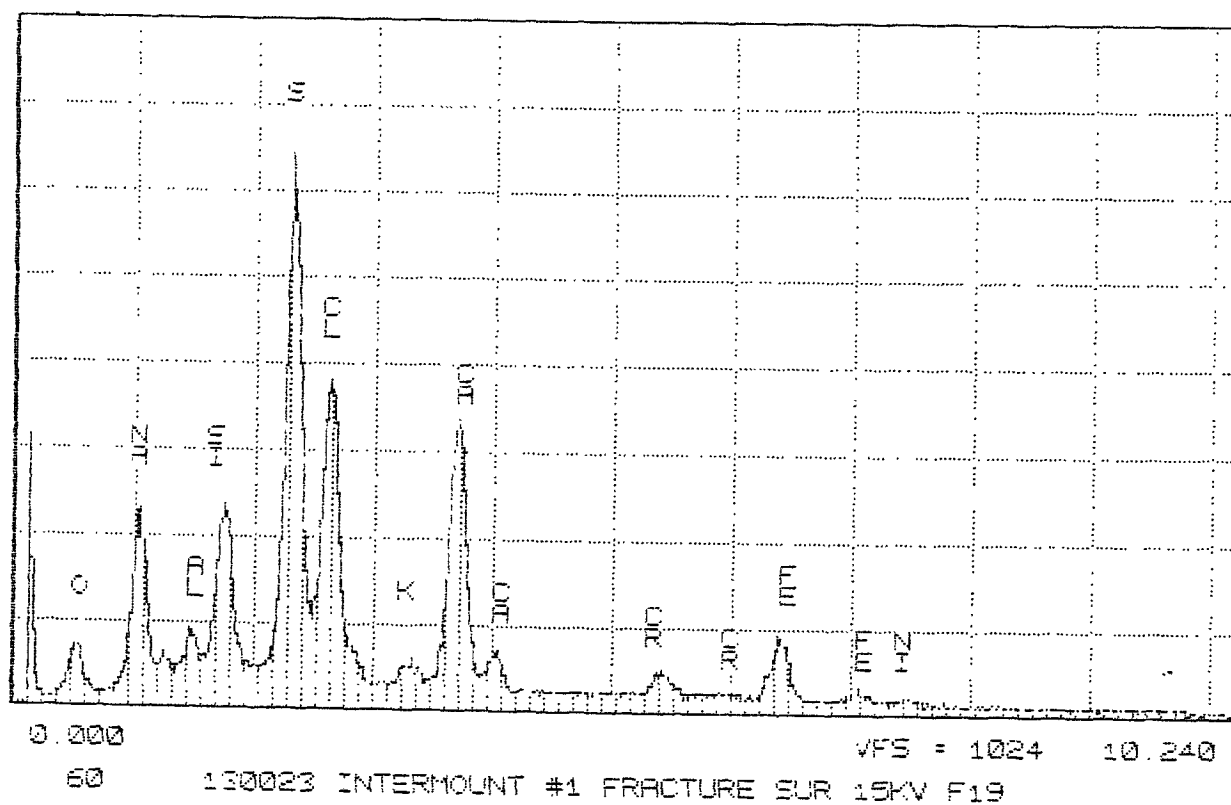
Locations D and E on the fracture surface, identified in Fig. 7, were also examined. The Energy Dispersive Spectral (EDS) plots of the fracture surface deposits are provided in Figs. 17 and 18. Very high levels of sulfur and chlorine were detected on the fracture surface. These contaminants are highly corrosive to austenitic stainless steels materials.

Fig. 17. Energy Dispersive Spectral (EDS) plot recorded of location D.

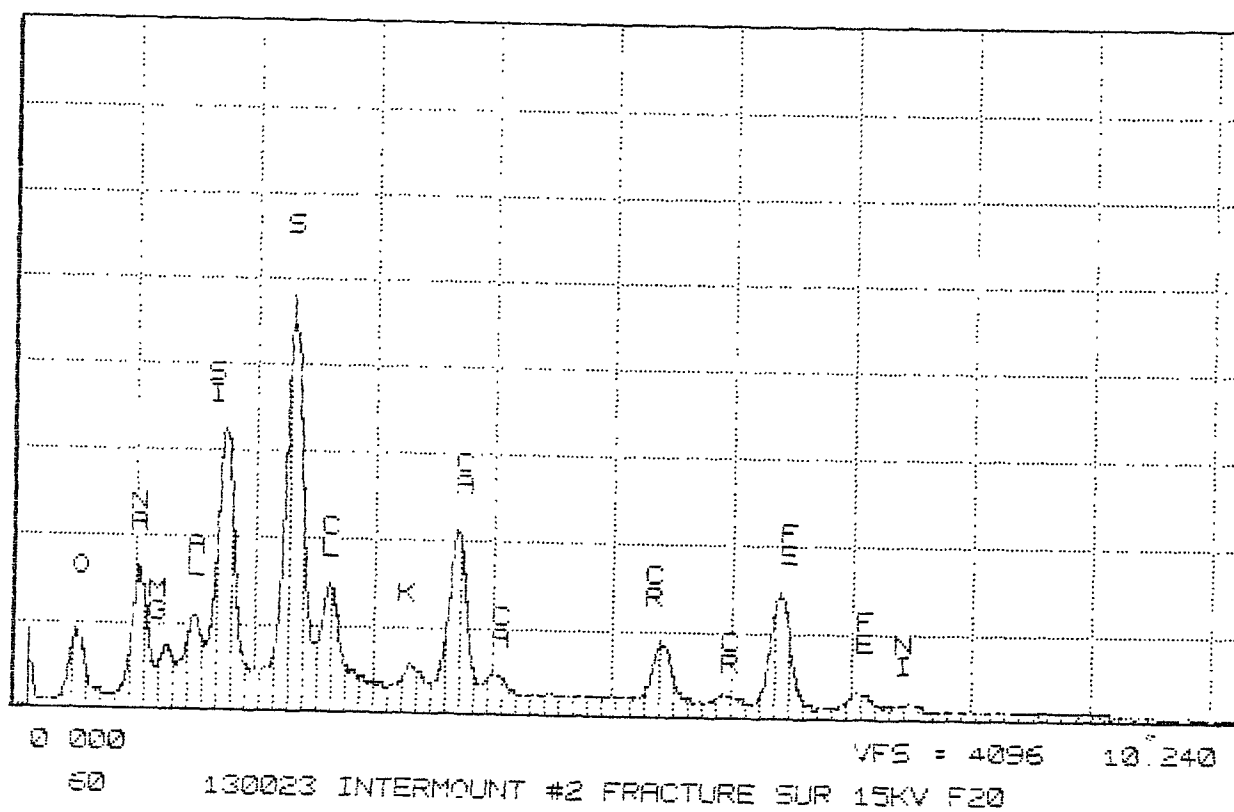
Fig. 18. Energy Dispersive Spectral (EDS) plot recorded of location E.

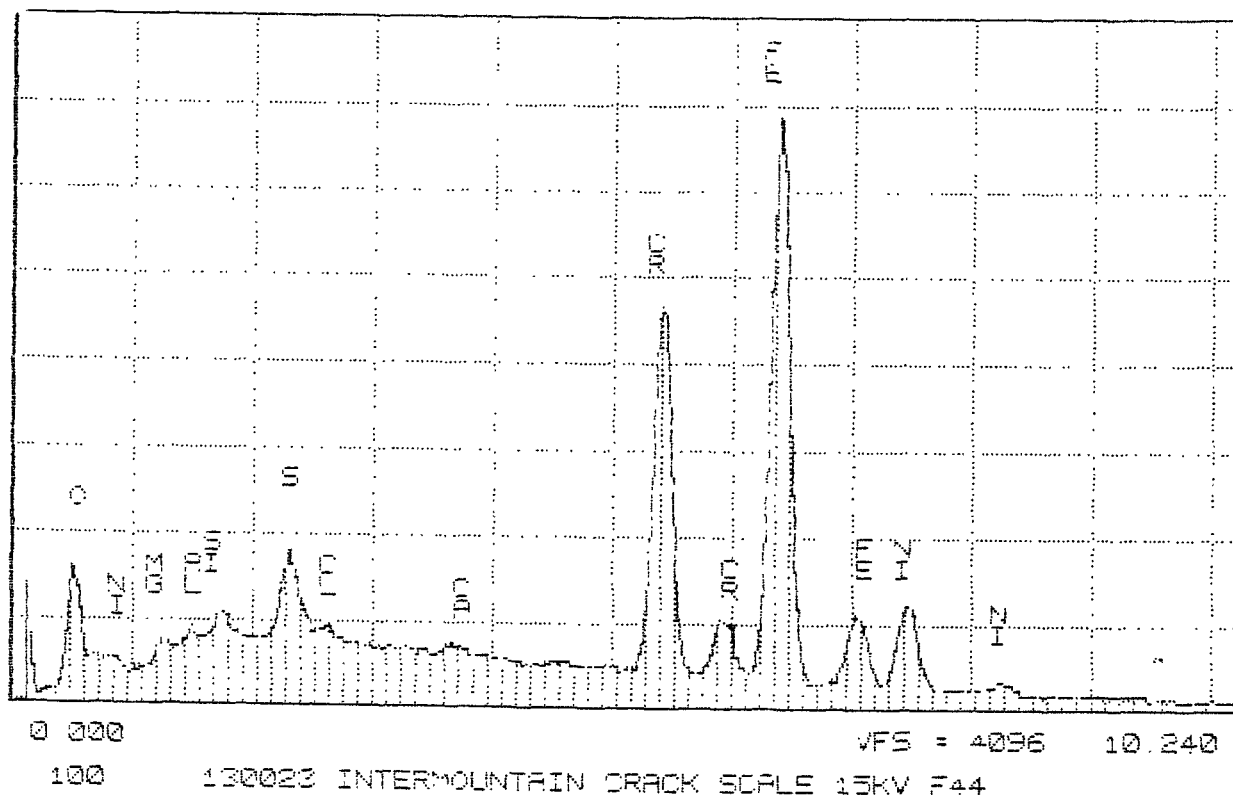
Fig. 19. Energy Dispersive Spectral (EDS) plot recorded of location F.

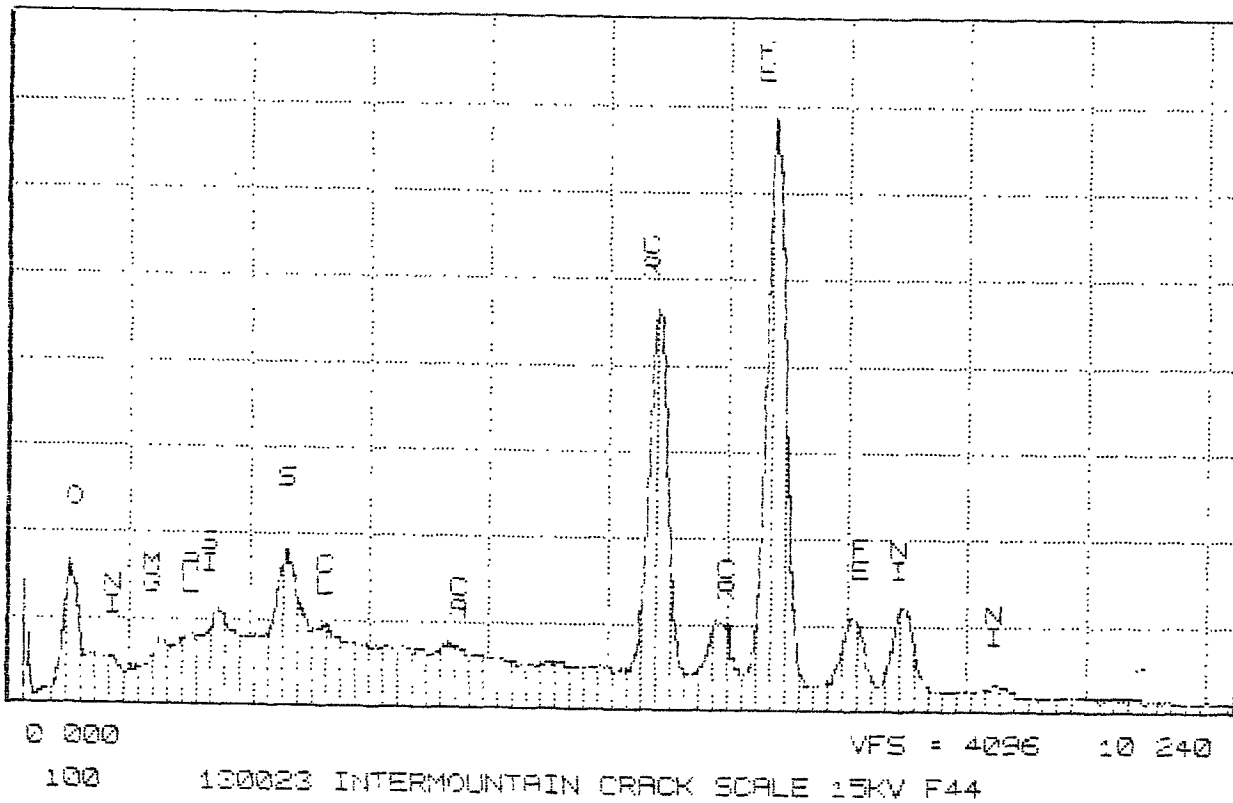
Fig. 20. Energy Dispersive Spectral (EDS) plot recorded of location G.

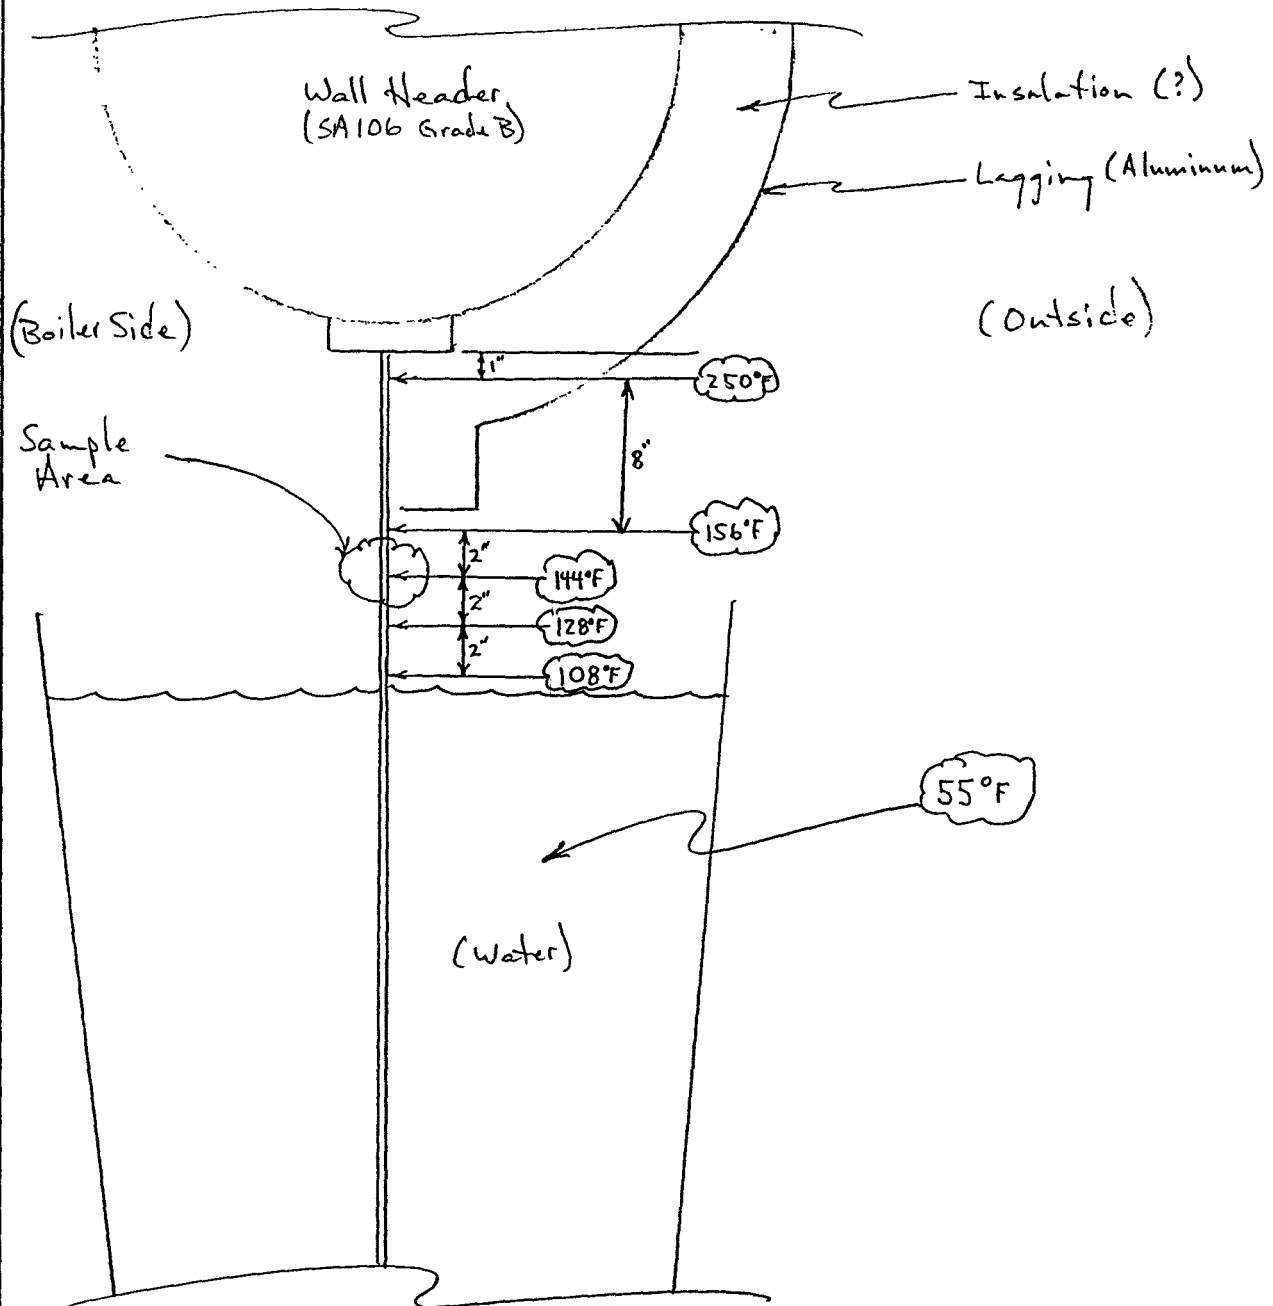
Bottom Ash Seal Curtain Temperature Gradients.

Maximum operating temperatures of the seal curtain were recorded at 500°F to 600°F. Some temperature fluctuations would be expected. The "non-submerged" portion of the curtain would be exposed to reflect radiant heat from the boiler. Appendix A illustrates the temperature gradient of the bottom ash seal curtain during normal operation. At the area of cracking, temperatures typically ranged from 144°F to 156°F.
